### Mulga Graze

#### **The use of new technology for water point monitoring.**

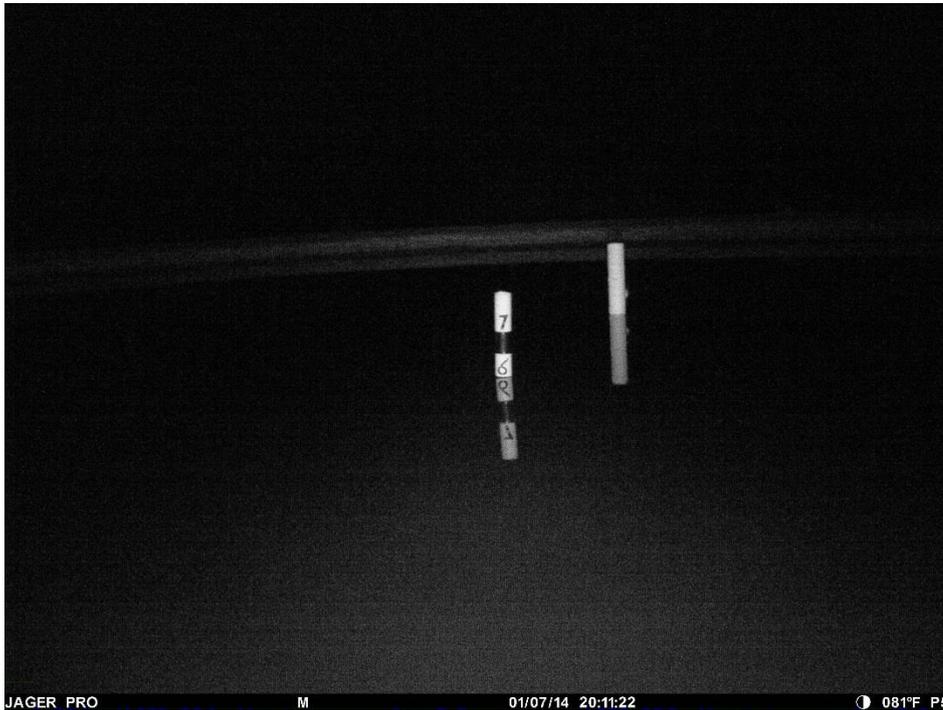
Above. An example of the image which was sent via email to the property owners email address. Which he was then able to check on his mobile phone.

This method of water point monitoring was developed and a trial was set up. The initial results were positive with the picture being emailed back and the water level of the storage tank being monitored daily.

The ability to remotely check the water level via the I.C.E camera meant that it saved an hour round trip to check the water level and guarantee that there was sufficient water available for the domestic stock. It also means that when the property owner is away from his property he is able to accurately monitor the water storage level. It also allows the property owner to check the water level as often as they like or need to.

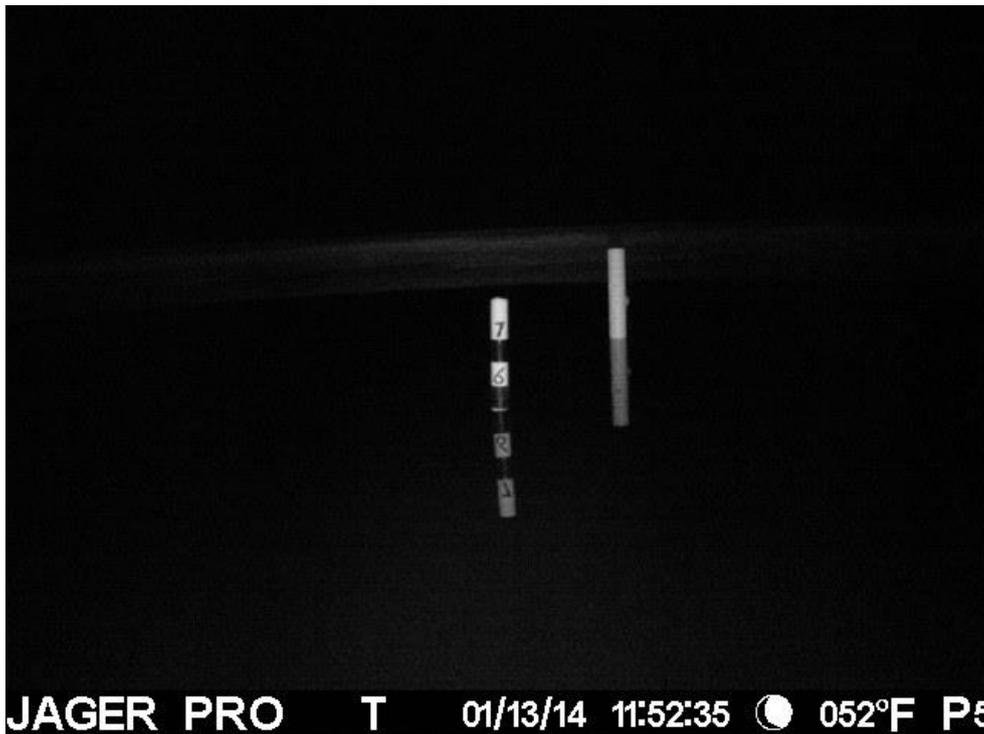
This is an image captured from the second trial. Please be aware that the time and date stamp down the bottom of this image is incorrect, this picture was actually taken on the 24<sup>th</sup> of May 2015 at 1:00am. This is solely due to operator error, they forgot to set the date when the camera was set up. Due to the remoteness of the site it hasn't been visited since to update the time and date stamp.

The trial is currently set up with the following method. The camera has been programmed to take a picture and email it every hour between 10pm and 2am. This is when the mobile phone signal is the strongest in the area, the pictures are then emailed back to the office where they activate a rule on office email program depending on the name of the camera. Once this rule has been activated the image is forwarded to the property owners email address. This rule can be edited so that a number of emails can be sent, there may be
